## Infra-red Technology

**Integrity Home Inspection Services** was called to do an inspection on a house that was just painted inside and out. The roof was older and showed signs of wear along with some rotting trim along the siding at the areas where the roof changed elevations. It had not rained for almost a week so moisture was not obviously present in any areas.

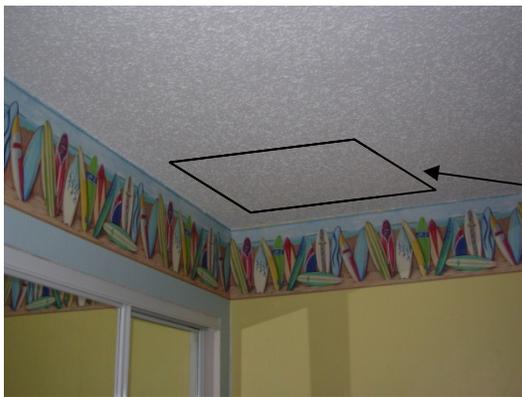
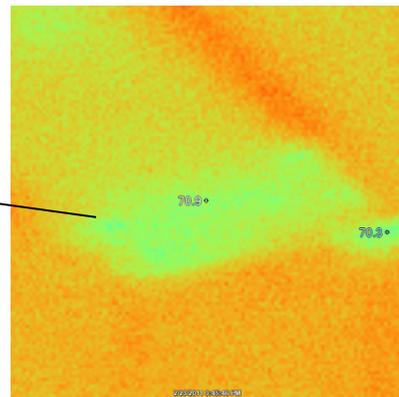
Prior to entering the attic, a thermal scan of the ceilings in the house was done to determine if there were any indications of moisture present; the results are seen below.

Without IR technology, this may have been missed considering the entire inside of the house had been re-painted and the attic insulation covered any damp areas. Once I found the spot shown below I verified my findings with a moisture meter from the attic side and sure enough there was moisture present in the drywall. In addition, there was the appearance of an old roof leak that had not yet been repaired.
