# Home Inspection Report

G01062017TVolkerson2340RiverTreeCir

Date: Fri. Jan. 6, 2017 9:00

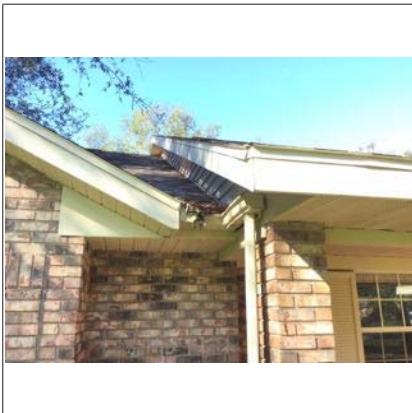
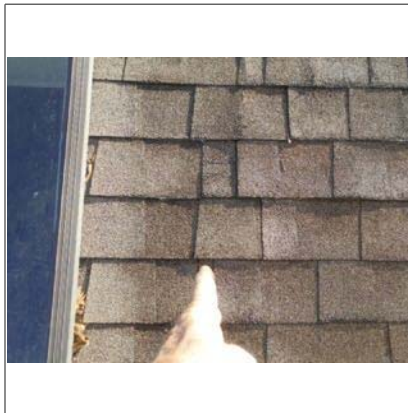
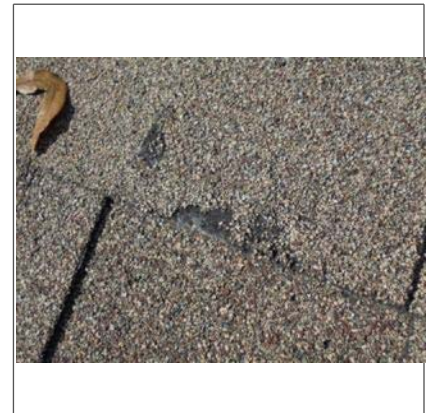
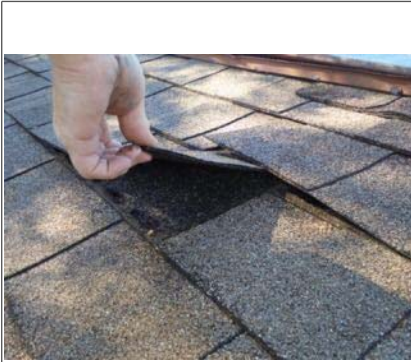
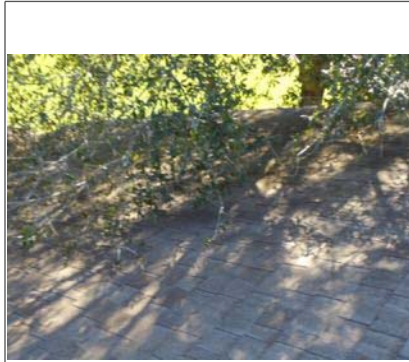
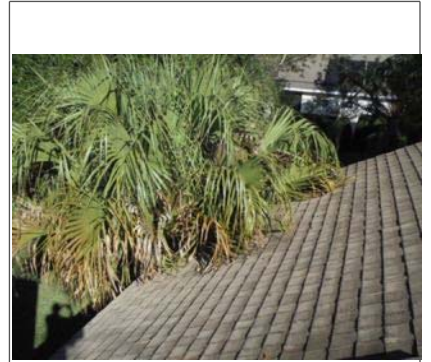
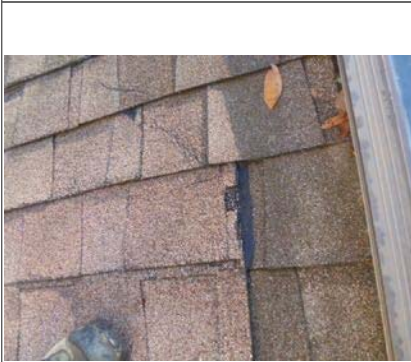
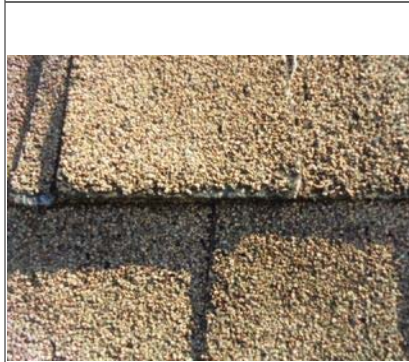
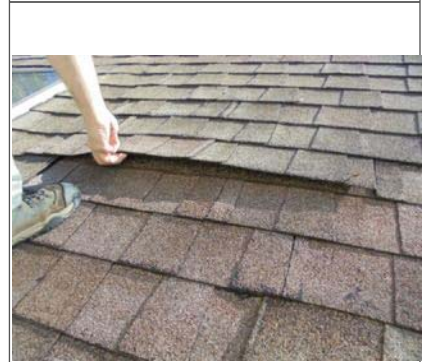
**Comments** Comments:  
 ROOF COMMENTS  
 --The roof is nearing the end of the manufacturers estimated life expectancy, Recommend budgeting for a new roof within the next 3 years.  
 --The roof is showing signs of age. Roof is lifting, missing granules, in need of repairs  
 --Landscape in contact with roof shingle  
 --Gutters full of debris

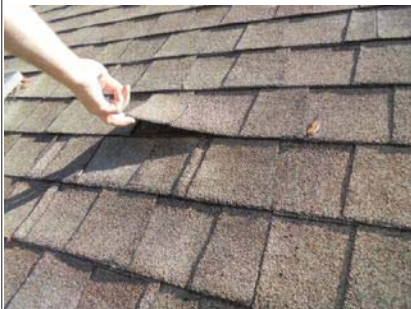
Recommend roofer evaluate shingle installation around skylights

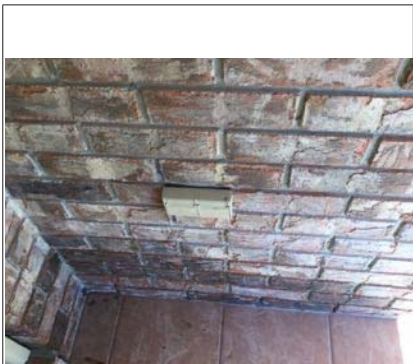
Loose electric outlet on front porch

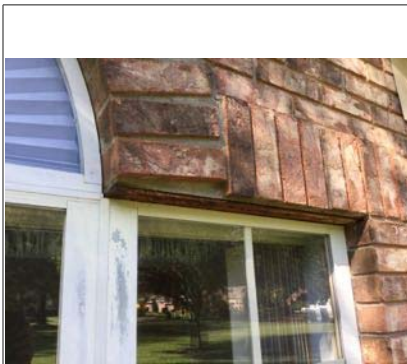
Brick lintels rusting

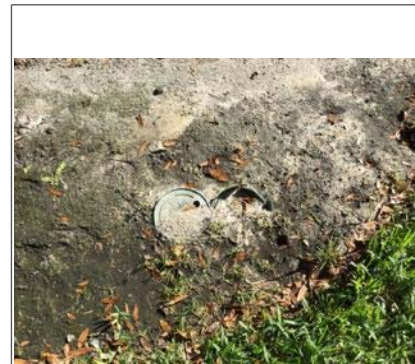
Damage irrigation valve box in rear planter bed

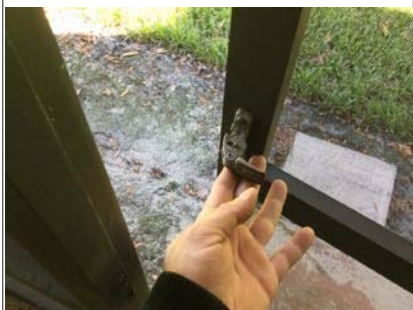
Rear enclosure door hardware not operating properly

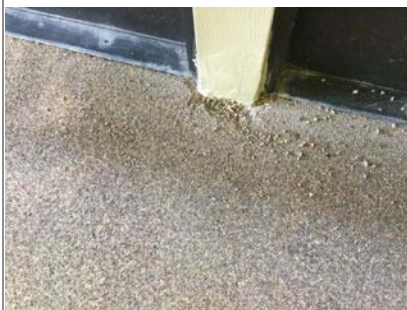
Rear lanai floor finish beginning to flake around base of post

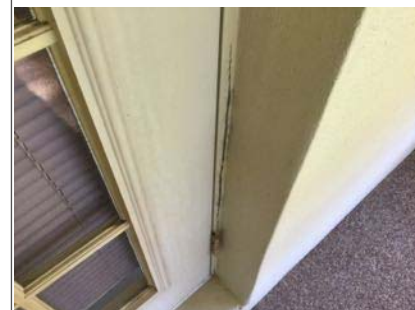
Caulk / Paint beginning to flake around bathroom door

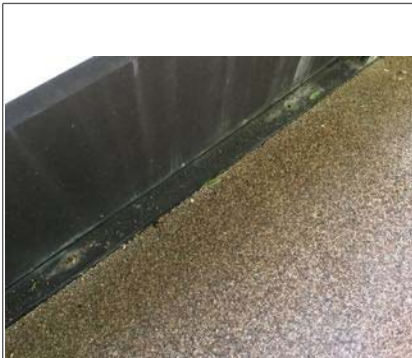
Screen enclosure anchor bolts beginning to rust / anchor bolts missing / loose screen panel(s)

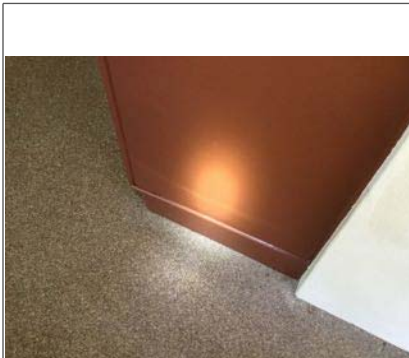
Lanai sink base cabinet panel appears to have absorbed moisture in the past

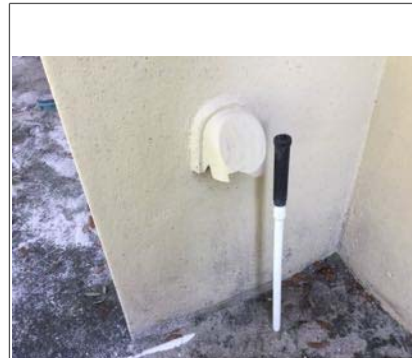
Chimney vent cover brittle / cracking

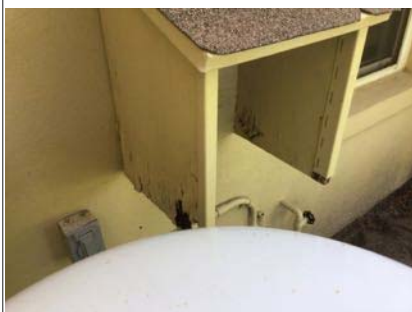
Moisture damaged wall box behind well equipment

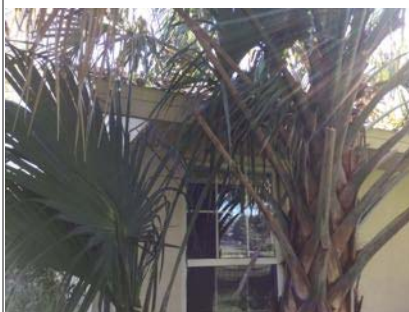
Landscape in contact with exterior walls / roof shingle

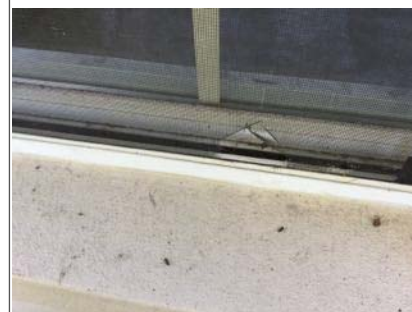
Torn / worn window screen(s) present

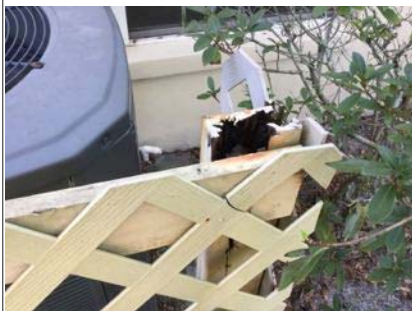
Moisture damaged framing along HVAC condenser screen

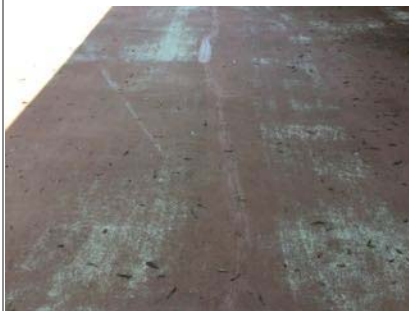
Typical concrete cracking through driveway

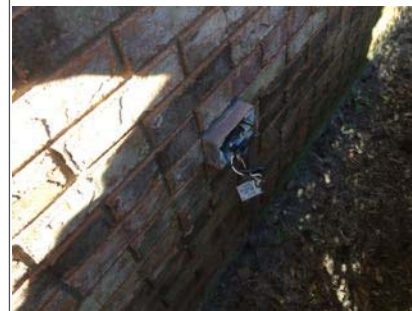
Exposed electrical connections behind lead walk hedgerow

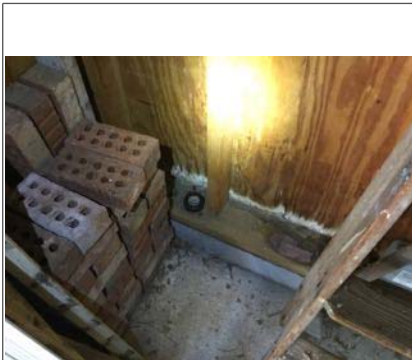
Moisture stained siding along sill of yard shed

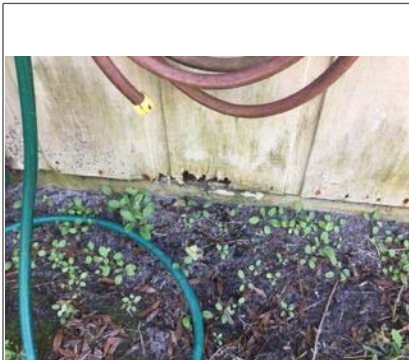
Moisture stained and or damaged siding along sill of yard shed

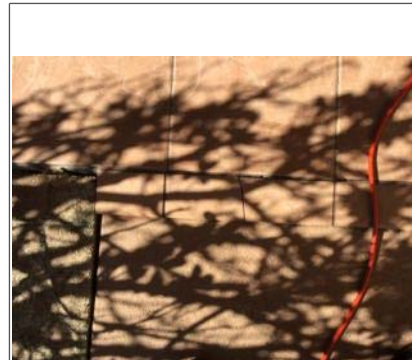
Cracked front porch floor tile

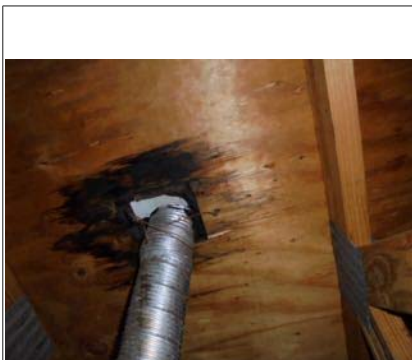
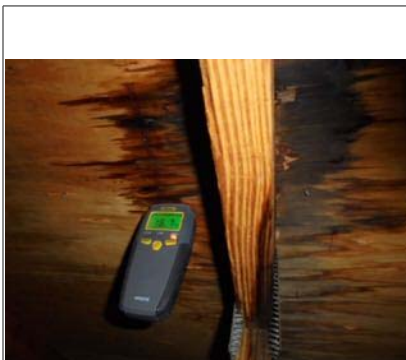
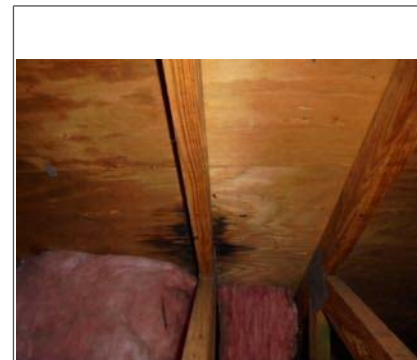
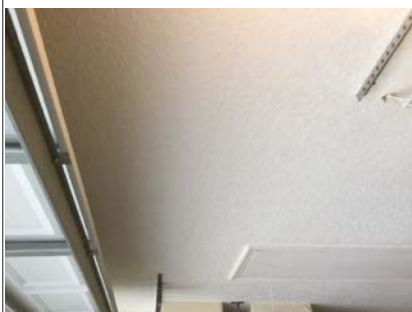
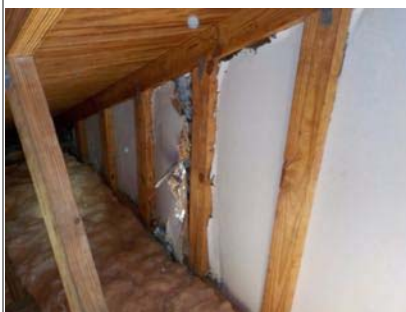
- Comments** Comments:  
 ATTIC COMMENTS  
 --Evidence of current roof leaks present in attic. Recommend contractor evaluate roof system  
 --Potential WDO activity present in attic behind garage gable

Potential WDO activity present in attic behind garage gable

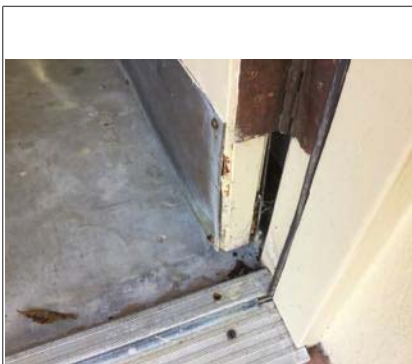
Service door panels beginning to rust / service door threshold was not securely attached

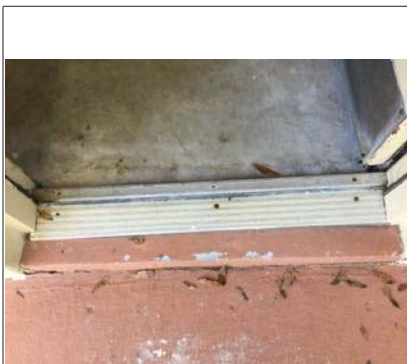
Service door thresholds was not securely attached

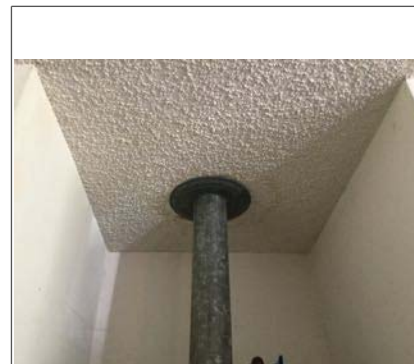
Moisture staining around water heater vent pipe ceiling penetration

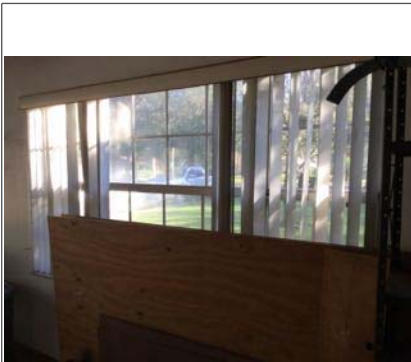
Garage windows difficult to operate / garage windows in need of service

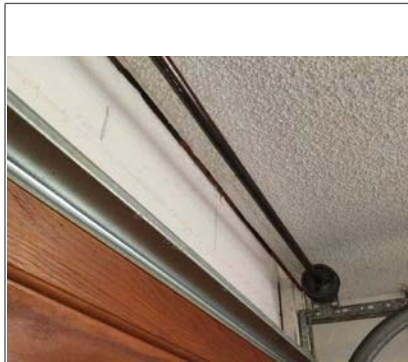
Drywall tape seam above overhead door missing / gap along wall - ceiling transition above overhead door

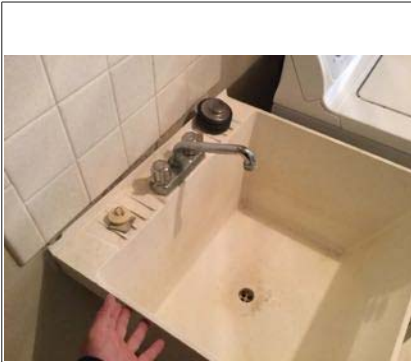
Utility sink was not securely attached

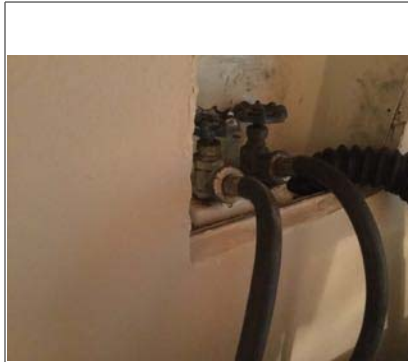
Washing machine supply hose leaks at connection

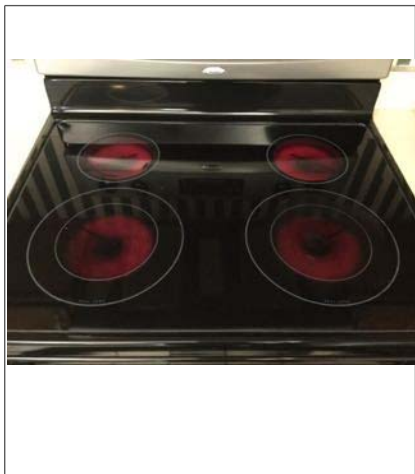
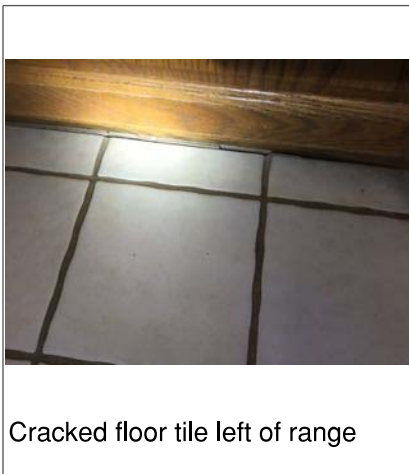
Cracked floor tile left of range

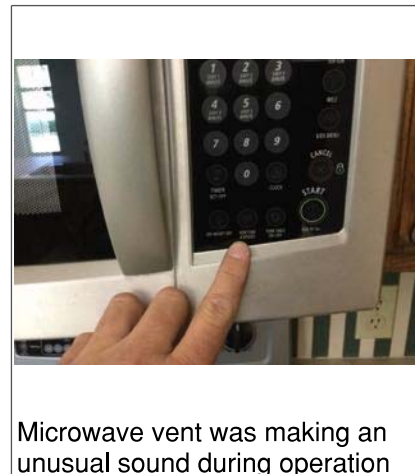
Microwave vent was making an unusual sound during operation

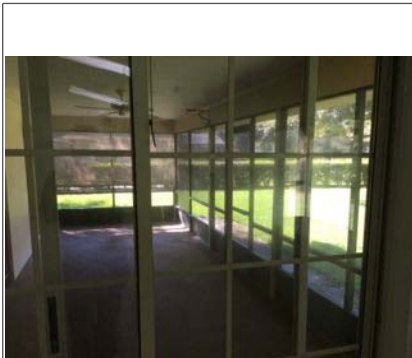
Apparent seal leak between double paned slider panel(s)

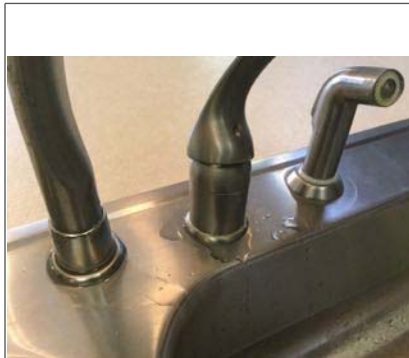
Kitchen faucet leaks from cartridge during operation

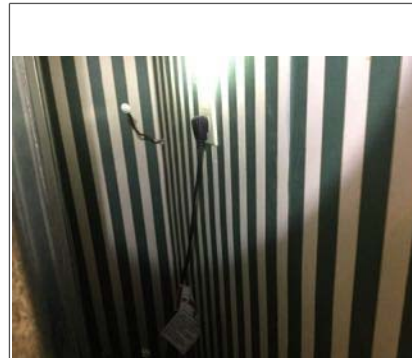
Refrigerator water line was not connected

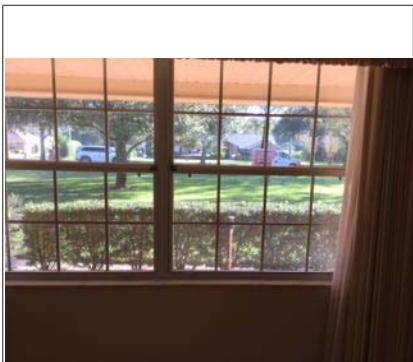
Window was difficult to operate / window in need of service

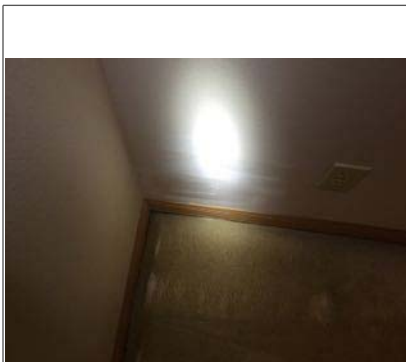
Visible drywall repair left of wing wall electric outlet

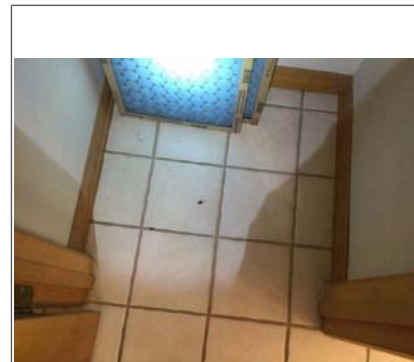
Two cracked floor tiles in coat closet

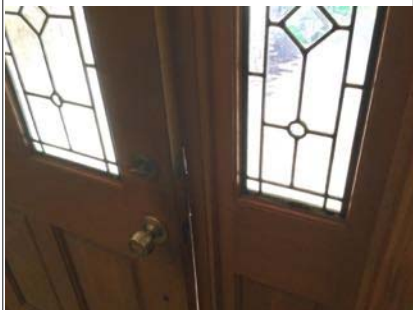
Front entry door contacts jamb during operation

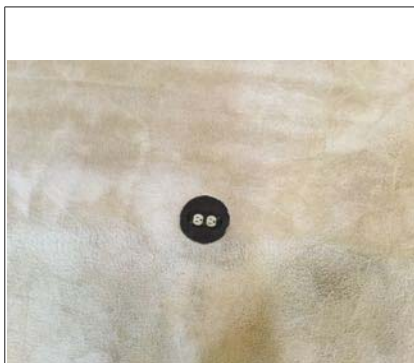
Floor outlet missing cover

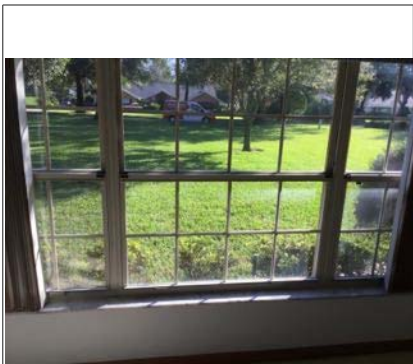
Window was difficult to operate / window in need of service

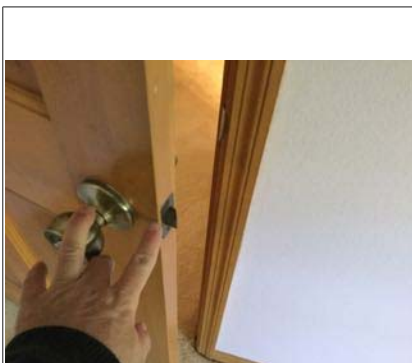
Entry door hardware not operating properly / entry door contacts jamb during operation

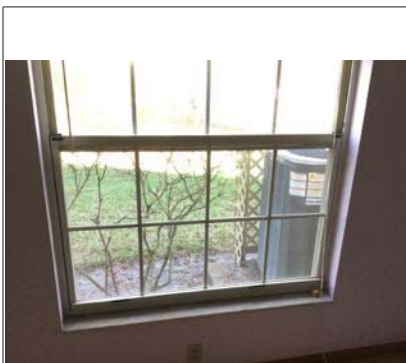
Window was not operating properly / window in need of service

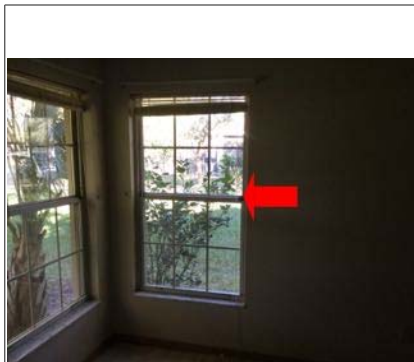
Window was difficult to operate /  
window in need of service

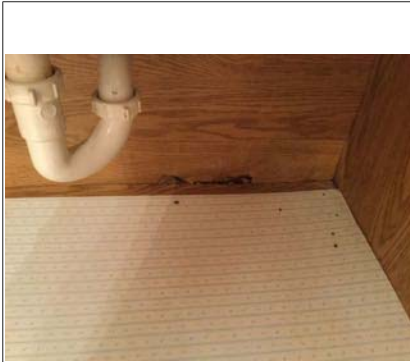
Some apparent moisture damage along bottom of vanity cabinet in master bedroom

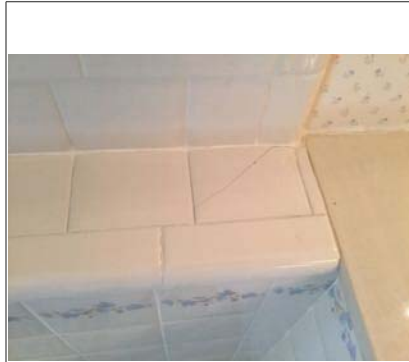
Cracked tile along tub shelf

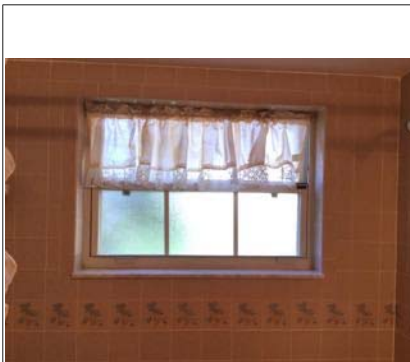
Window difficult to operate / window in need of service

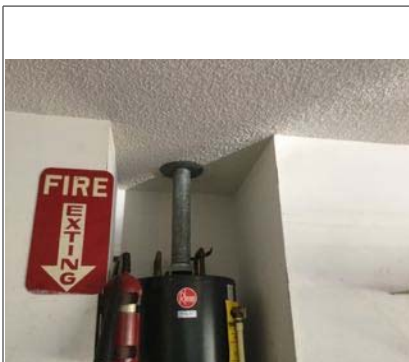
No combustion air vent present for gas water heater

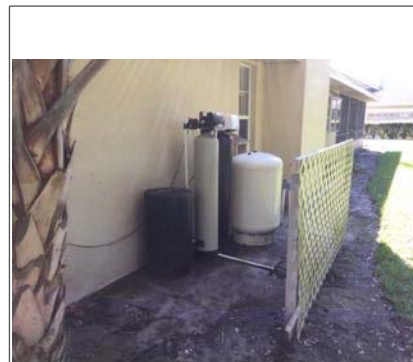
Well equipment exposed to elements

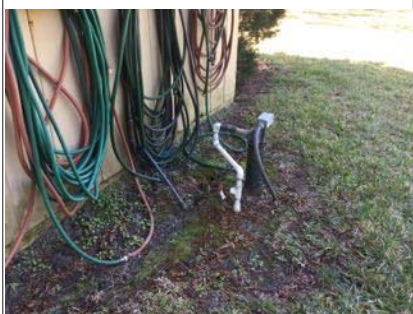
Well head exposed to elements

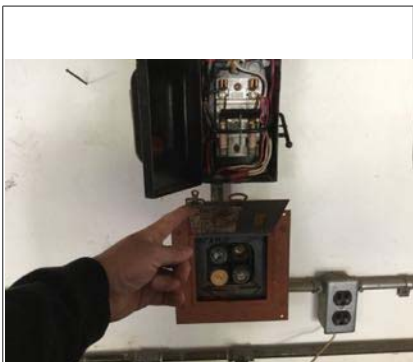
Fused electric circuits present in garage , recommend electrician evaluate

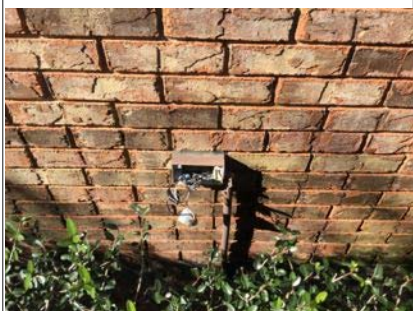
Exposed electrical connections behind lead walk hedgerow
