# Home Inspection Report

G01062017TVolkerson2340RiverTreeCir

Date: Fri. Jan. 6, 2017 9:00

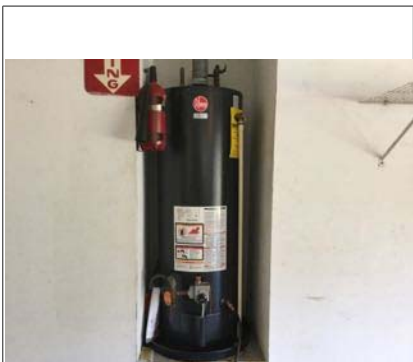
**Comments** Comments:  
PLUMBING COMMENTS  
--No combustion air vent present for gas water heater  
--Well head and equipment exposed to elements

Gas water heater 5 years old

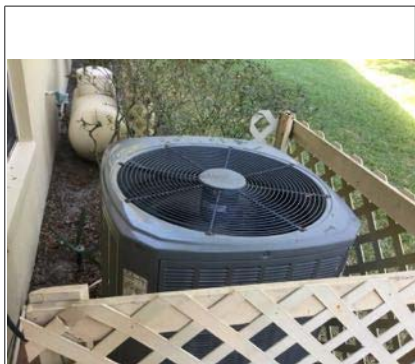
HVAC condenser 7 years old

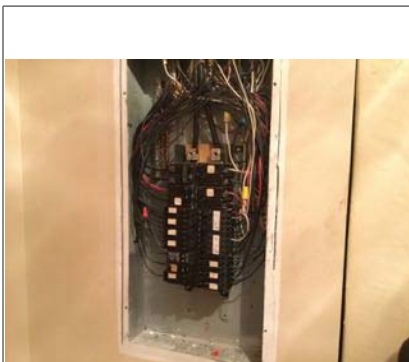
Fused electric circuits present in garage , recommend electrician evaluate

Crouse Hinds electric sub panel in laundry room

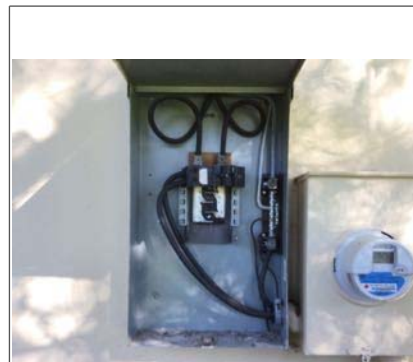
Crouse Hinds electric main panel 150a
